**DEPARTMENT OF TRANSPORTATION****DIVISION OF ENGINEERING SERVICES**

Contract #: 04-0120F4Cty: SF/ALA Rte: 80 PM: 13.2/13.9File #: 69.28**WELDING INSPECTION REPORT****Resident Engineer:** Pursell, Gary**Address:** 333 Burma Road**City:** Oakland, CA 94607**Report No:** WIR-000886**Date Inspected:** 20-Nov-2007**Project Name:** SAS Superstructure**OSM Arrival Time:** 1400**Prime Contractor:** American Bridge/Fluor Enterprises, a JV**OSM Departure Time:** 2330**Contractor:** Zhenhua Port Machinery Company, Ltd (ZPMC), Changxing Island **Location:** Shanghai, China

# WELDING INSPECTION REPORT

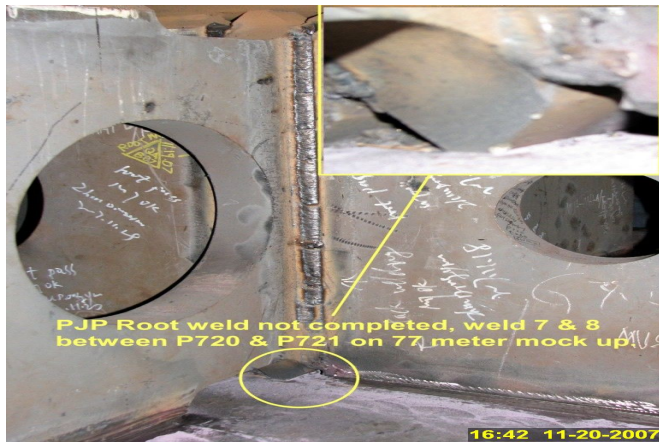
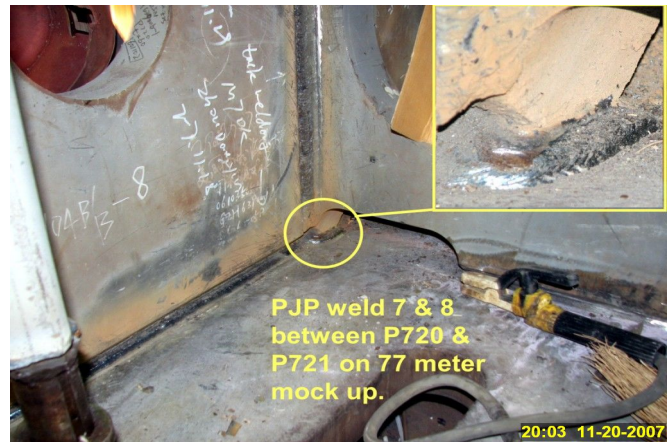
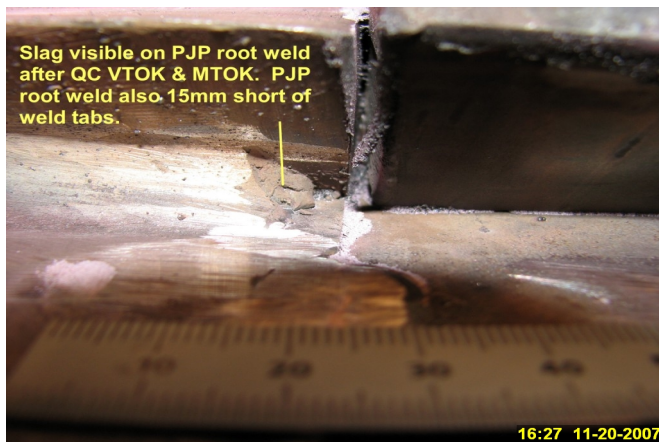
that PJP welds 7 & 8 between P720 & P721 are not welded. The QA inspector was informed that those root welds will be welded and inspected later. The QA inspector also noted that all observed PJP root weld inspections were conducted with the base metals at ambient temperatures.

The QA inspector later observed welding in progress on the above mentioned PJP welds (#7 & #8) that, to the QA inspector's knowledge had no visual inspection or MT on the PJP root weld. The QA inspector asked the QCL Lay Tou if there has been any additional inspection of the PJP root welds. The QCL replied that the welds were all inspected earlier, when the QA inspector was present. The QA inspector asked the QCL to further inquire on the root welds and the QCL was shown the welds that the QA inspector observed and noted were not completed. The QCL spoke with several ZPMC personnel near the work and could not provide any further information regarding additional inspection of the previously unwelded/un-inspected PJP root welds. The QA inspector attempted to make further observations of the parts, however heating pads were put in place by ZPMC workers and no observations could be conducted.
